Application Note #1507

Targeted Nanoindentation of a High-Entropy Alloy in the SEM

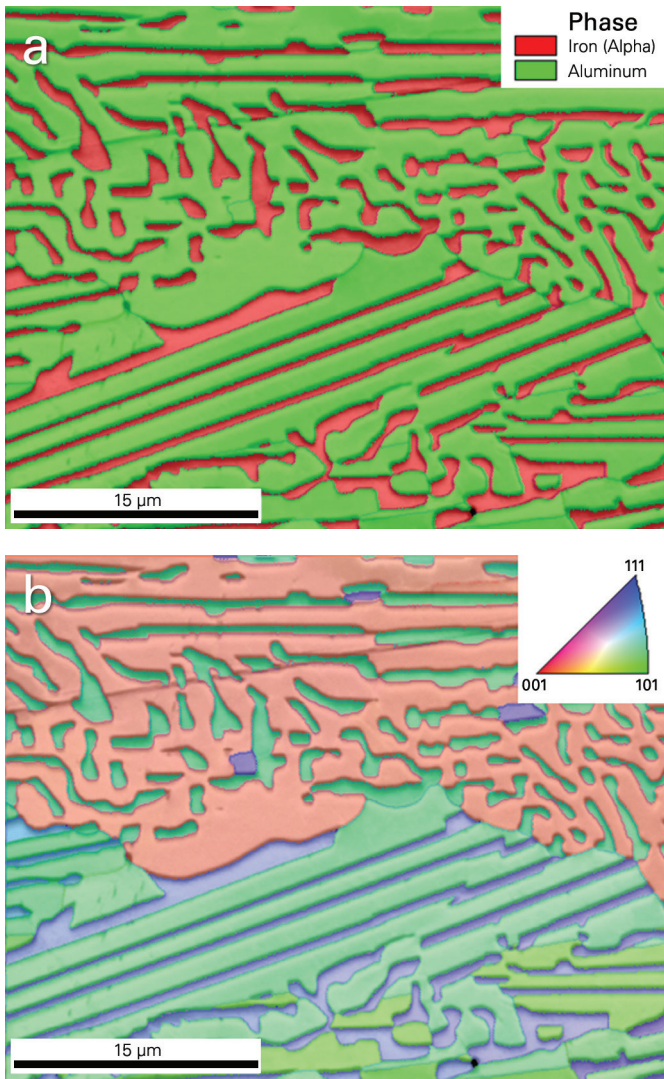
Figure 1. EBSD analysis of a portion of the HEA sample: (a) phase map showing the BCC phase in red and the FCC phase in green and (b) inverse pole figure map showing the orientations within each grain (since both phases are cubic, only one pole map is needed).

The high-entropy alloy utilized for this study was as cast, and was prepared using conventional mechanical polishing and a final chemo-mechanical vibratory polish with colloidal silica. This material had a composition of AlCoCrFeNi_{2.1} and separated into two high-symmetry crystal phases, FCC (L1₂) and BCC (B2) phases, with about 65-35% volume fraction distribution, respectively [3]. This is shown by electron backscatter diffraction (EBSD) in Figure 1. In Figure 1a, the two phases as identified by EBSD are marked, with the FCC phase in green and the BCC phase in red. In Figure 1c, the inverse pole figure map indicates that the same orientation is maintained with an individual "fiber" of the microstructure, which is an elongated lamellar structure. Indentation tests targeting specific parts of the microstructure was performed in-situ SEM using the Hysitron PI 88 equipped with a Berkovich geometry probe in load control, with partial unload indents to measure the depth dependence of the properties. The indentation testing was performed at tilt to allow visualization of the test, and the optional rotation and tilt staging of the Hysitron PI 88 was used to reorient the specimen, post-mortem, with the electron column for backscatter (BSE) imaging and phase identification of the indent locations.

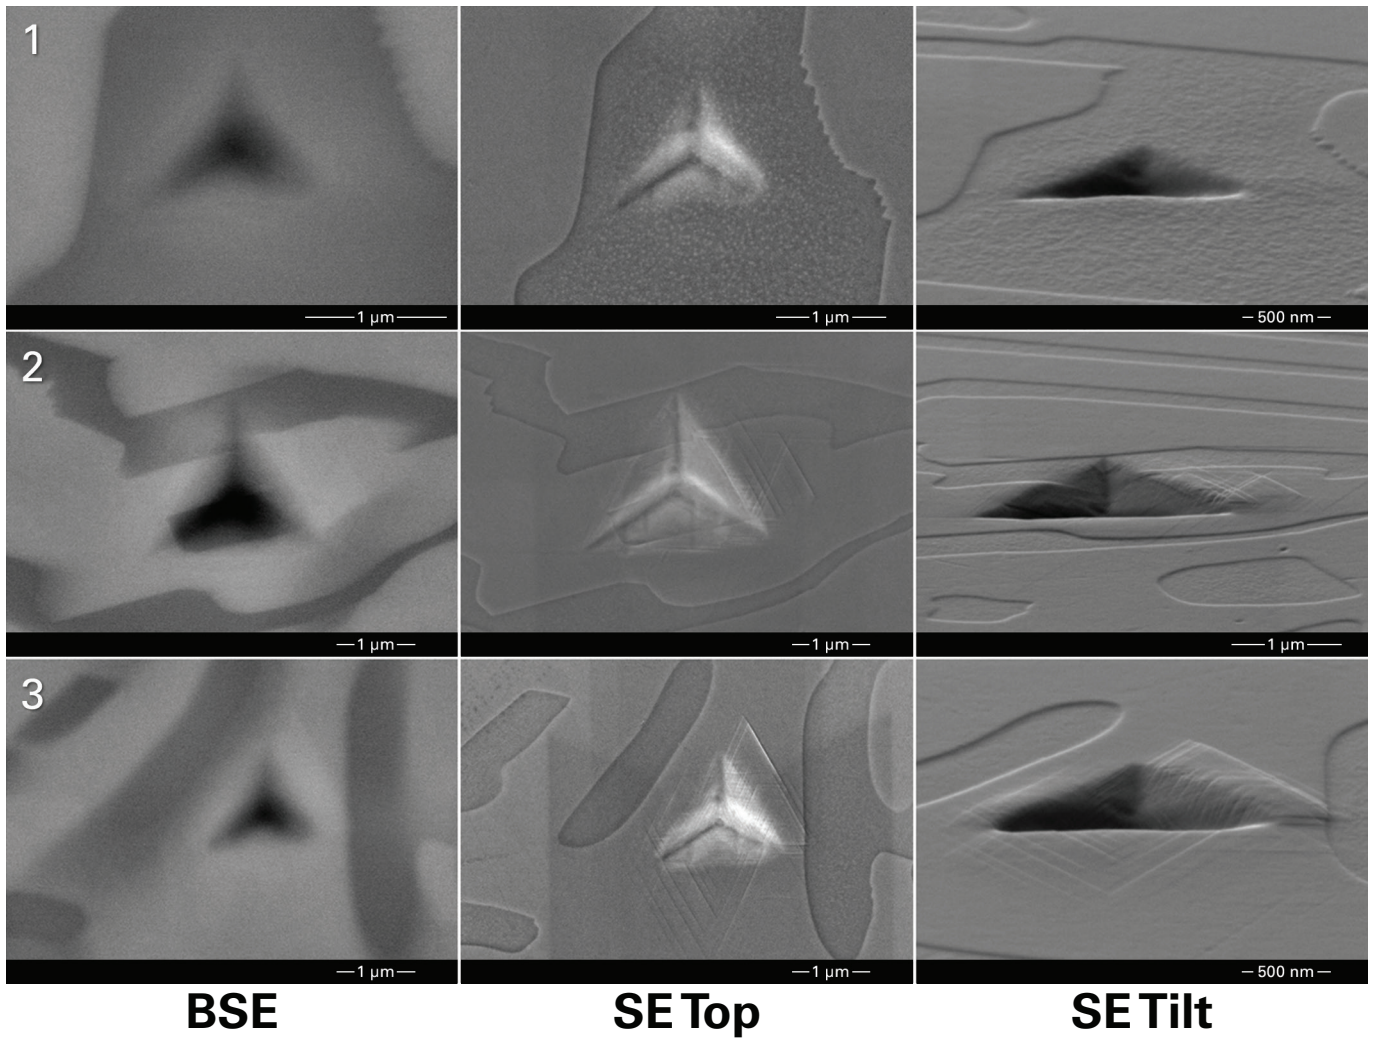
Figure 2. Post-indent imaging of three regions of the HEA microstructure, with backscatter imaging and secondary electron imaging from the top and from a tilted perspective. The regions are divided by rows and marked on the left.

For the in-situ SEM indentation, regions were selected that represented different parts of the materials microstructure. Three example indentation regions are compared in Figures 2 and 3. In Figure 2, post-indent imaging is shown for these regions, in backscatter electron mode and secondary electron mode, both from a top view and a tilted view, respectively. Region 1 is within the minor BCC phase, which appears slightly darker than the FCC phase. Region 2 is a combination of the two phases, while Region 3 is predominantly within the FCC phase. In the post-indent imaging, slip steps are not apparent in Region 1, while they do occur in Regions 2 and 3 within the FCC phase. This is reasonable, as slip by dislocation is more easily promoted in the FCC crystal structure. It can also be observed in Regions 2 and 3 that the slip steps pile up against the nearby BCC phase boundary.

The hardness data in Figure 3 is correlated to the propensity to form slip steps from the images in Figure 2. In Region 1, the hardness is relatively constant with depth at ~10 GPa. In Region 2, the hardness is similar to Region 1 at the lowest depths, which is reasonable as the center portion of the indent is in the BCC phase. However, as the depth increases, the hardness drops as increasing amounts of FCC phase is incorporated in the plastic zone of the indent. The hardness approaches that of Region 3, which is predominately within the FCC Region. This has a relatively constant hardness around 6 GPa. These observations are consistent with TEM analysis of cold-rolled material, where it was observed that the BCC phase largely retained its structure, while the FCC grain structure deformed around it [3].

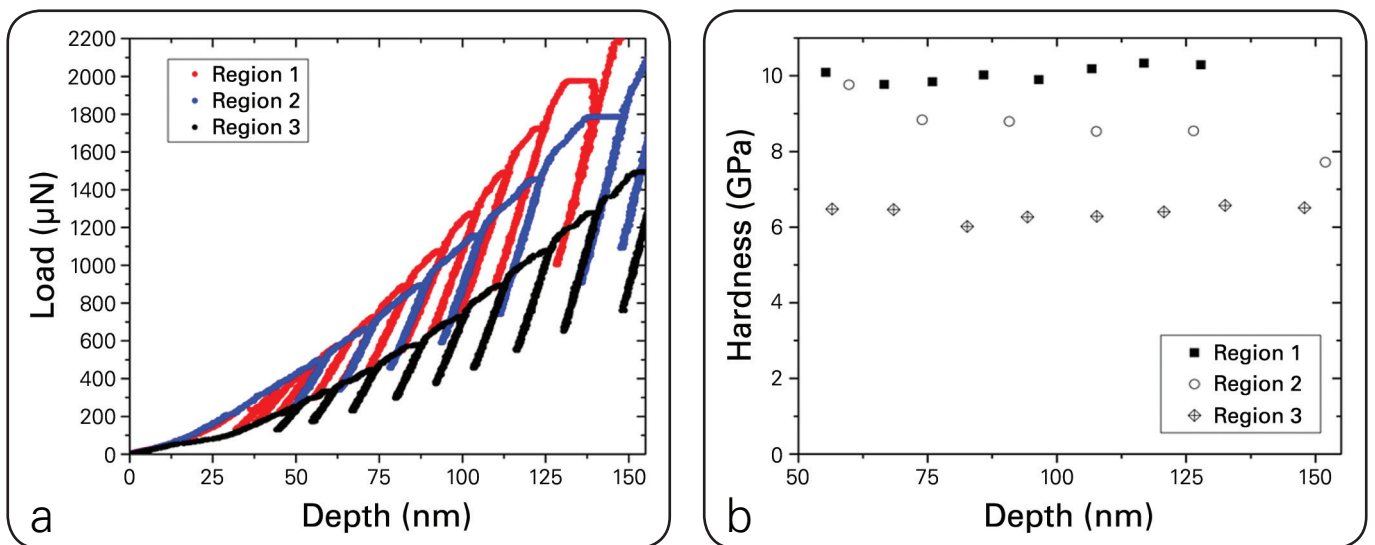
Figure 3. (a) Low depth portion of the load-displacement curves for the three regions of interest and (b) hardness versus depth from the analysis of the curves in part (a).
